Kolaitis, D., Asimakopoulou, E., & Founti, M. (2013). *A natural fire test to assess the behavior of modern timber construction techniques: light timber frame vs. glued laminated timber*. Paper presented at Interflam 2013.

A NATURAL FIRE TEST TO ASSESS THE BEHAVIOUR OF MODERN TIMBER CONSTRUCTION TECHNIQUES: LIGHT TIMBER FRAME VS. GLUED LAMINATED TIMBER

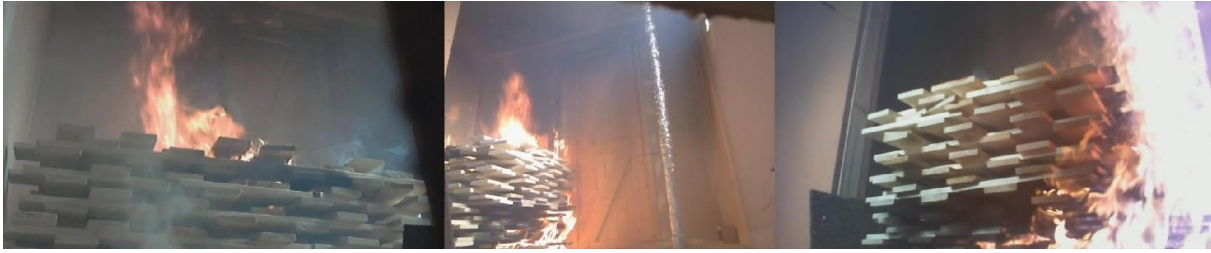
The fire is initiated by igniting a paraffin soaked fabric located under the wood crib. A rapid increase of the fire power is observed during the initial fire growth stage (Fig. 3); the gaseous temperature quickly reaches 750°C (Fig. 4, left). Approximately 9 min after fire initiation, there is a sudden decrease in the gas temperatures; a local minimum (420°C) is reached at the 11 min mark. A sudden drop in oxygen concentration is also recorded at the same time period (9 - 11 min). This behaviour suggests that under-ventilated fire conditions are temporarily established in the compartment, owed to the rapidly increasing concentrations of combustion products; however, the ambient air entrainment through the window results in a gradual increase of the indoors oxygen concentration, thus allowing gas temperatures to regain their previous levels, roughly 13 min after fire initiation. Approximately 17 min after fire initiation, the fire growth stage is completed, as gas temperatures reach their peak values (830°C). Fully developed fire

Figure 3. Stills from indoors video recording cameras, 3 min after fire initiation.
